NATIONAL RESEARCH COUNCIL OF CANADA  
DIVISION OF BUILDING RESEARCH

A STUDY OF THE LIME MORTAR BRICKWORK  
OF A 26-YEAR-OLD HOUSE

Report No. 168  
of the  
Division of Building Research

OTTAWA  
January 1959

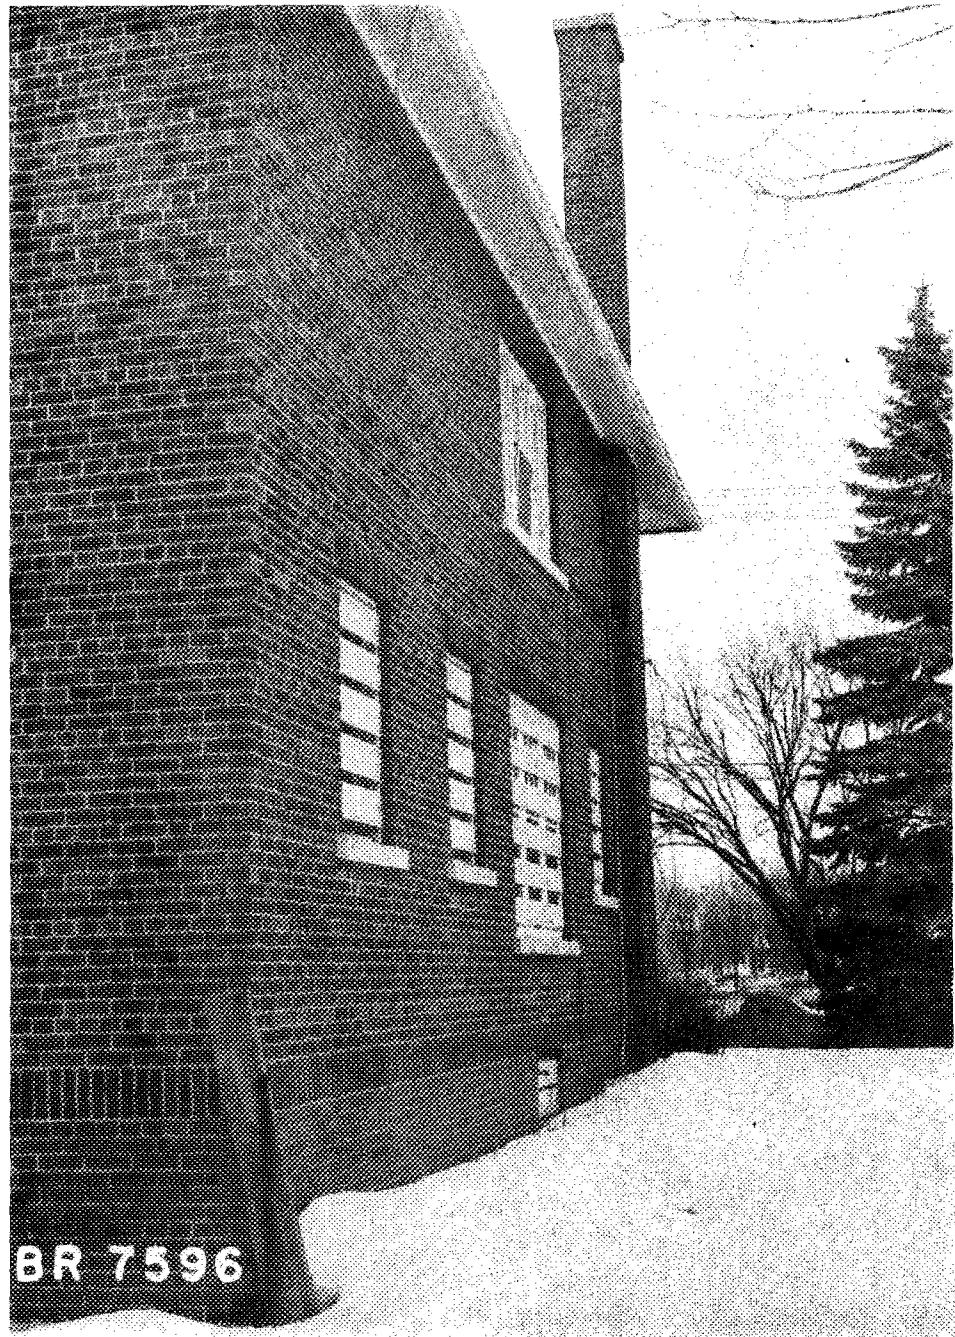
Figure 3 East and south walls

The brickwork of the house appeared to be in excellent condition. The bricks and mortar gave no indication of weathering decay. The east wall and part of the north, of apparently sound brickwork, are shown in Fig. 3.

The brickwork over the windows was carried on steel angles, the deflection of which apparently had caused cracks in the brickwork at the corners of the windows.

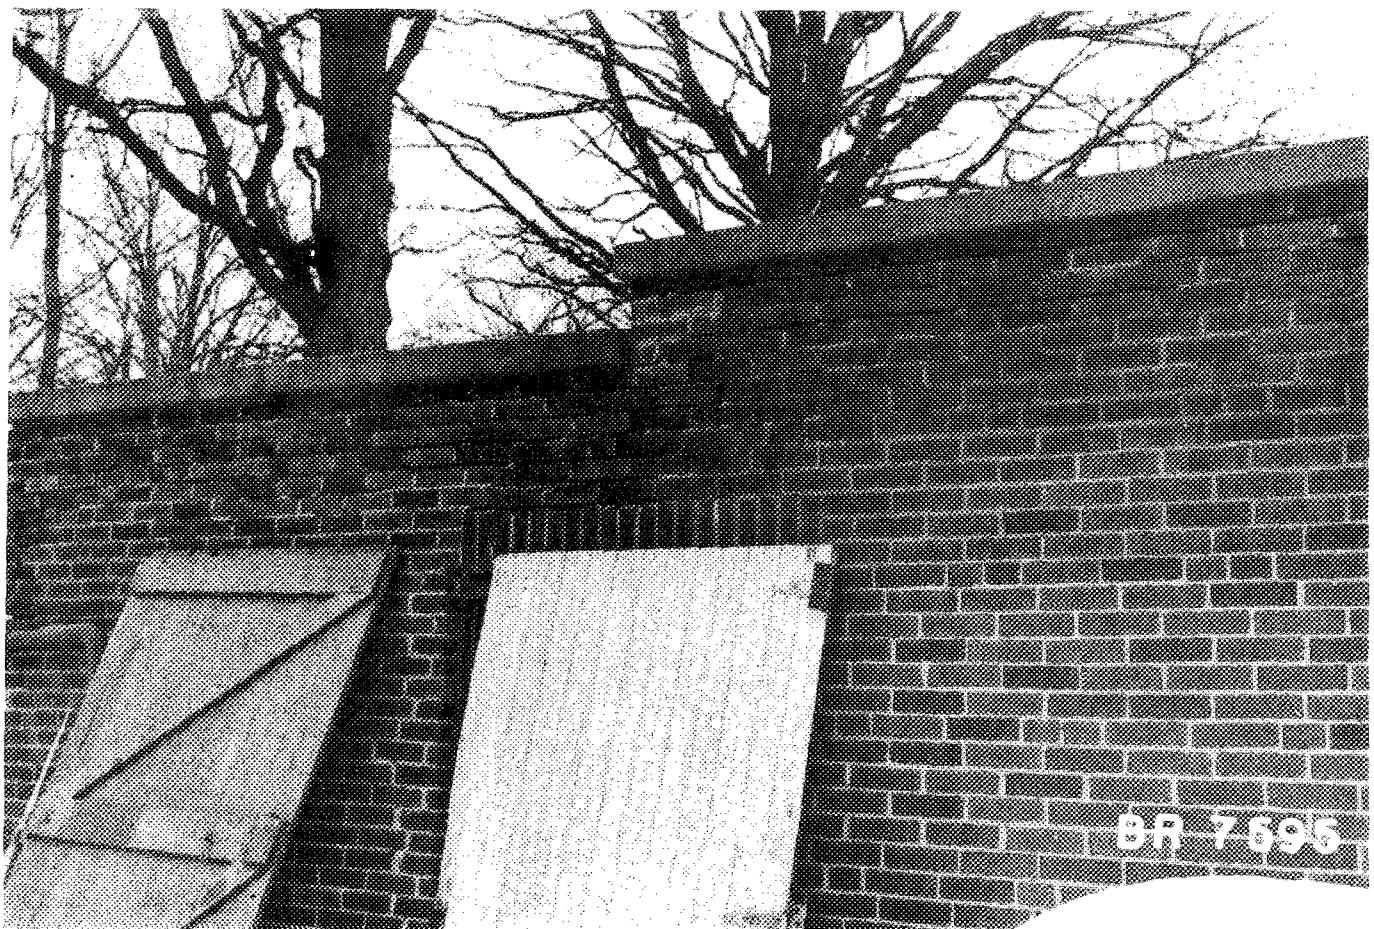
Figure 4 East wall of the garage

A separate garage was constructed of the same materials as the house, but had a flat roof surrounded by a low parapet wall. The parapet wall was capped with cast-in-place concrete; the brickwork immediately below was in poor condition, the mortar having come away from the joints in many places. The east wall of the garage is shown in Fig. 4.

The difference between the conditions of the upper parts of the garage walls and of the walls of the house was very striking. It seemed to correspond to

the different degrees of protection afforded to the brickwork by the contrasting roof structures. It was not ascertained, whether, in the case of the garage walls, proper flashings had been installed between the parapet and the roof to protect the masonry.

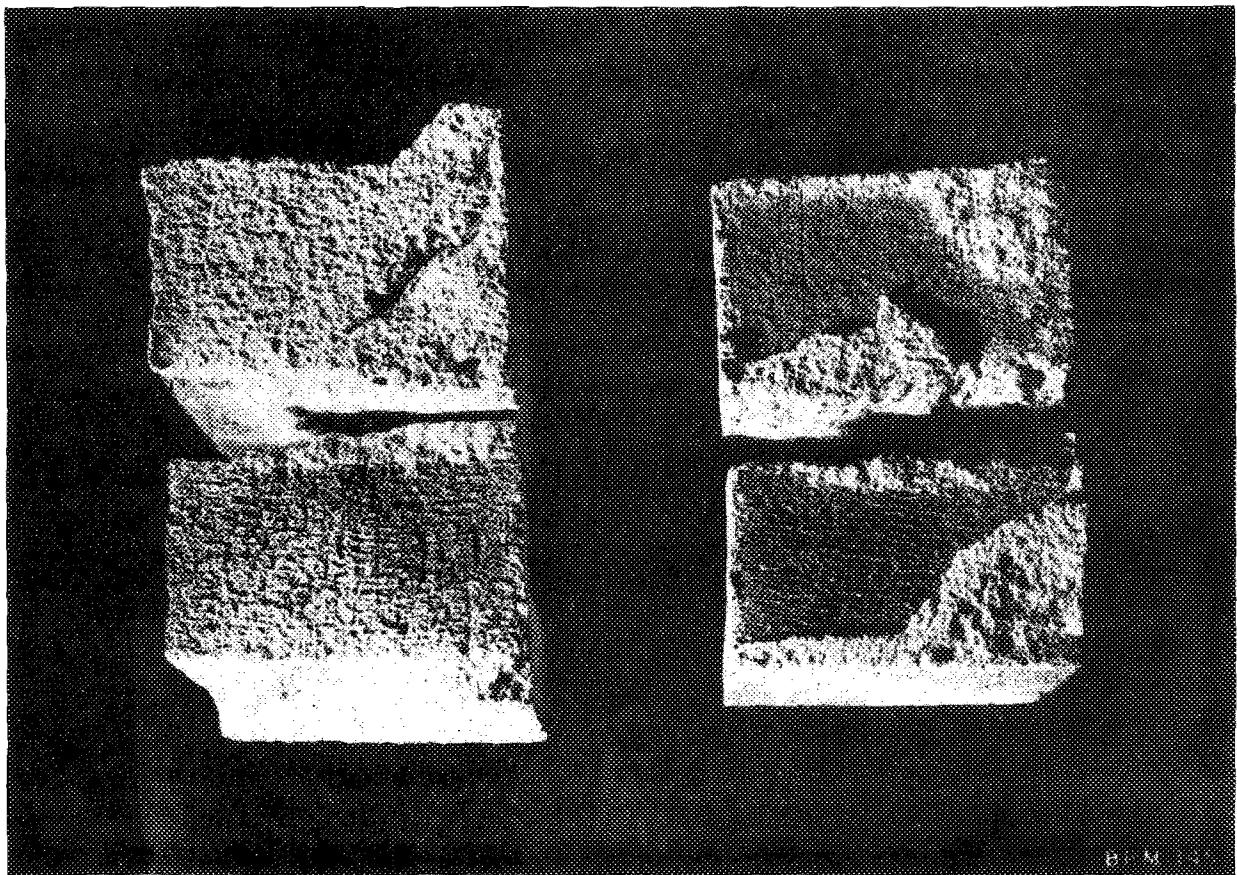
Figure 5a Mortar-brick unbonded areas

In spite of the good condition of the brickwork of the house, when the bricks and mortar were taken apart, it was noted that faulty bricklaying techniques had frequently resulted in incompletely filled and unbonded joints. This observation also applied to the garage. Almost all the vertical joints between the ends of stretcher-course bricks were incompletely filled. The same was true of the vertical joints of the soldier course which girdled the house at the top of the foundation. These joints were probably purposely underfilled to facilitate the alignment of the bricks. The resulting brickwork was admirable in appearance but its value may have been marred by the poor contact between bricks and mortar.

In the buildings studied, not only were the unfilled areas of the joints of course lacking in any strength, but also there was often a lack of intimate contact between the brick and mortar in the immediate surroundings. Many of the cavities in unfilled joints harboured insects and other small life. A number of cocoons were found in one such shelter.

Figures 5a and 5b illustrate unfilled vertical joints of both stretcher and soldier courses. Figure 5a also shows, at left, a fairly well filled end joint of a stretcher course, which was not pressed together sufficiently for the mortar to enter the depressions of the textured surface of one brick.

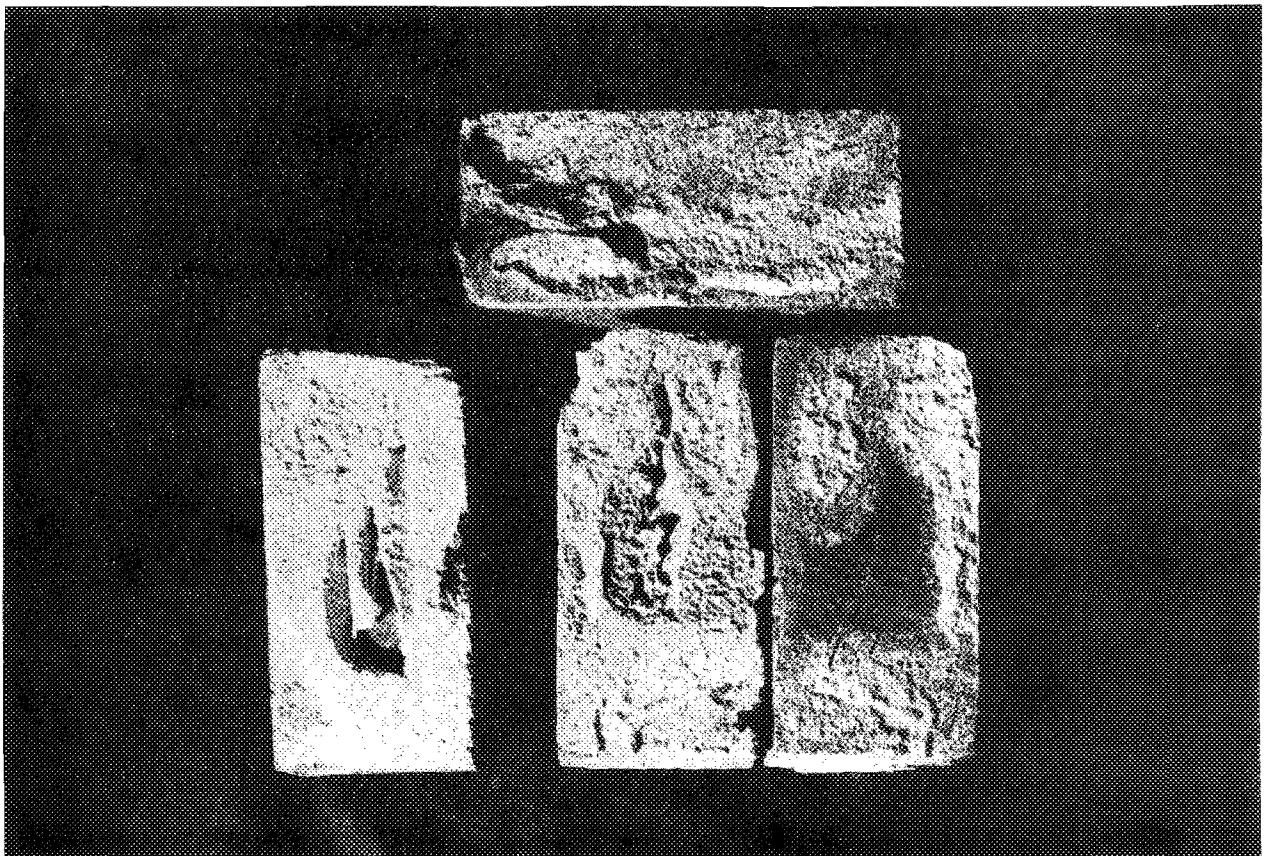
Figure 5b Unfilled vertical joints of soldier and stretcher courses

Mortar joints are left unfilled for several reasons, the main one probably being that less effort is required to push bricks into mortar beds having empty centres. The mortar at the edges of the joints is allowed to squeeze inward as well as outward, thus reducing the net areas of mortar placed under pressure. A second reason, important in regard to vertical joints, is that the trowel and materials are conveniently handled so that often only a little mortar is dabbed onto the areas to be joined. A third reason may also be that the workmen try to save mortar.

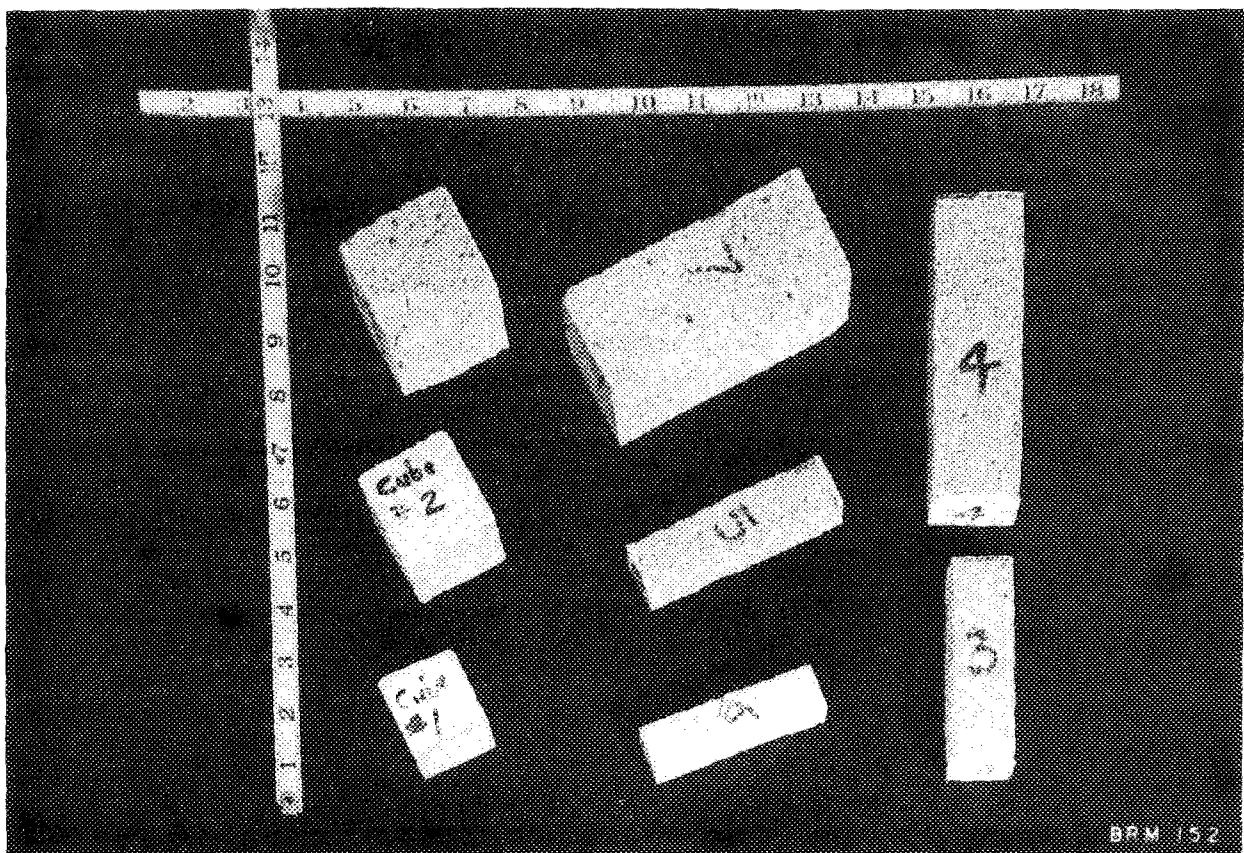
Figure 8 Mortar samples

Some of the mortar cubes and prisms are shown in Fig. 8. Two serious flaws in the largest cube are evident; it contains a large amount of unmixed lime which is badly cracked and a long, thin void. Similar flaws

were common since the mortar had not been prepared for test purposes; they undoubtedly contributed to low compressive strengths and E values.

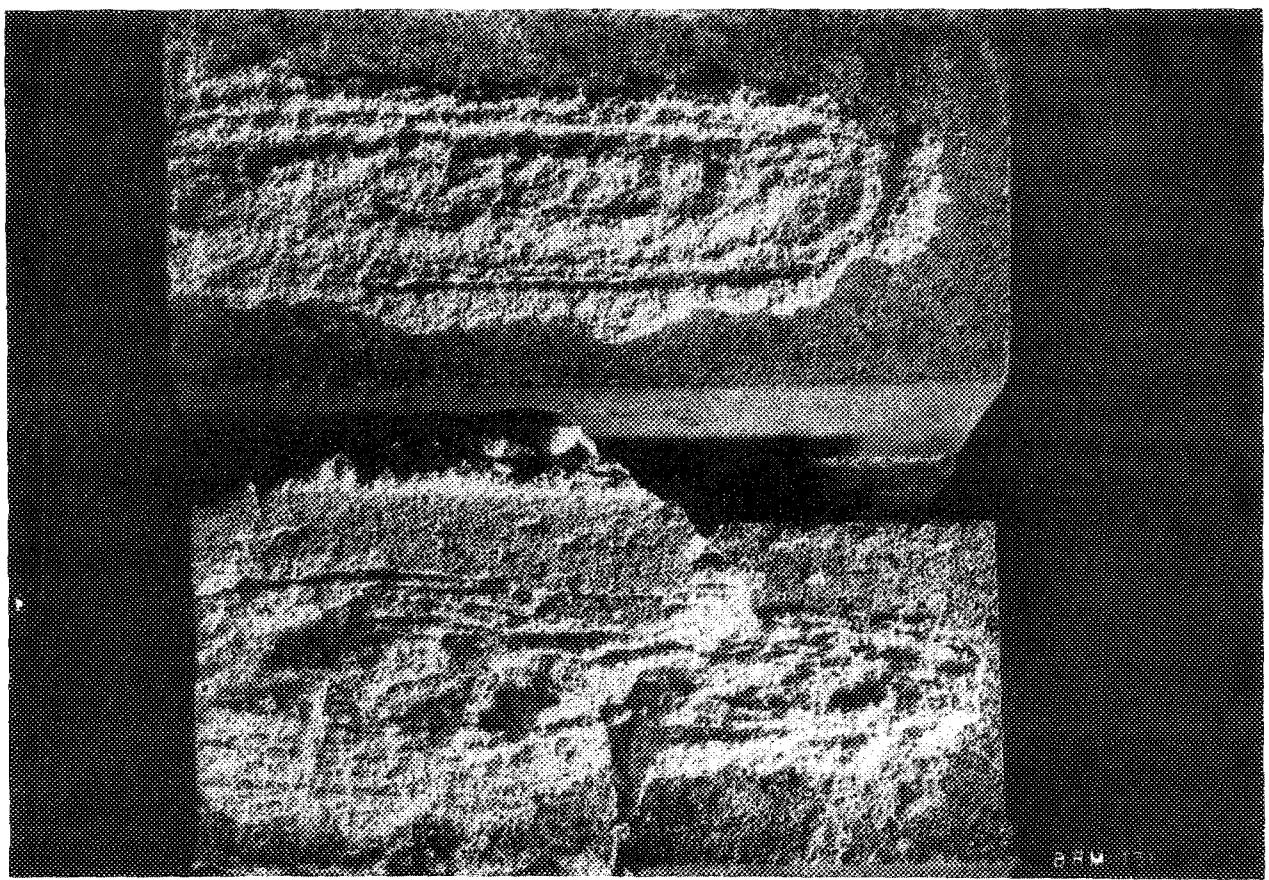
Figure 9a Patterns in mortar (two broken joints)

An interesting phenomenon was noticed regarding many of the mortar joints, in which a singular ridge and trough pattern stood out in relief on the surface of the mortar when it was separated from the brick. The patterns resembled the etched wood grain of a weathered flat-sawn board. They were revealed even when the joints were broken apart but were particularly clear when the diamond saw was used to separate the brick from the mortar. In the latter case the patterns were apparently etched from the sawing plane by the high-speed spray of cooling water thrown off by the whirling blade.

The patterns are illustrated in Figs. 9a and 9b; the upper photograph shows the mortar in two broken joints, while the lower demonstrates how the patterns were revealed by sawing.

One possible explanation of the mortar patterns is that they resulted from carbonation of the lime during cycling conditions of wet and dry, or perhaps of heat and cold. The process may have worked continuously and progressively inward through the mortar joints from all exposed faces, or under some conditions, even in the reverse direction (i.e., from the center outward).

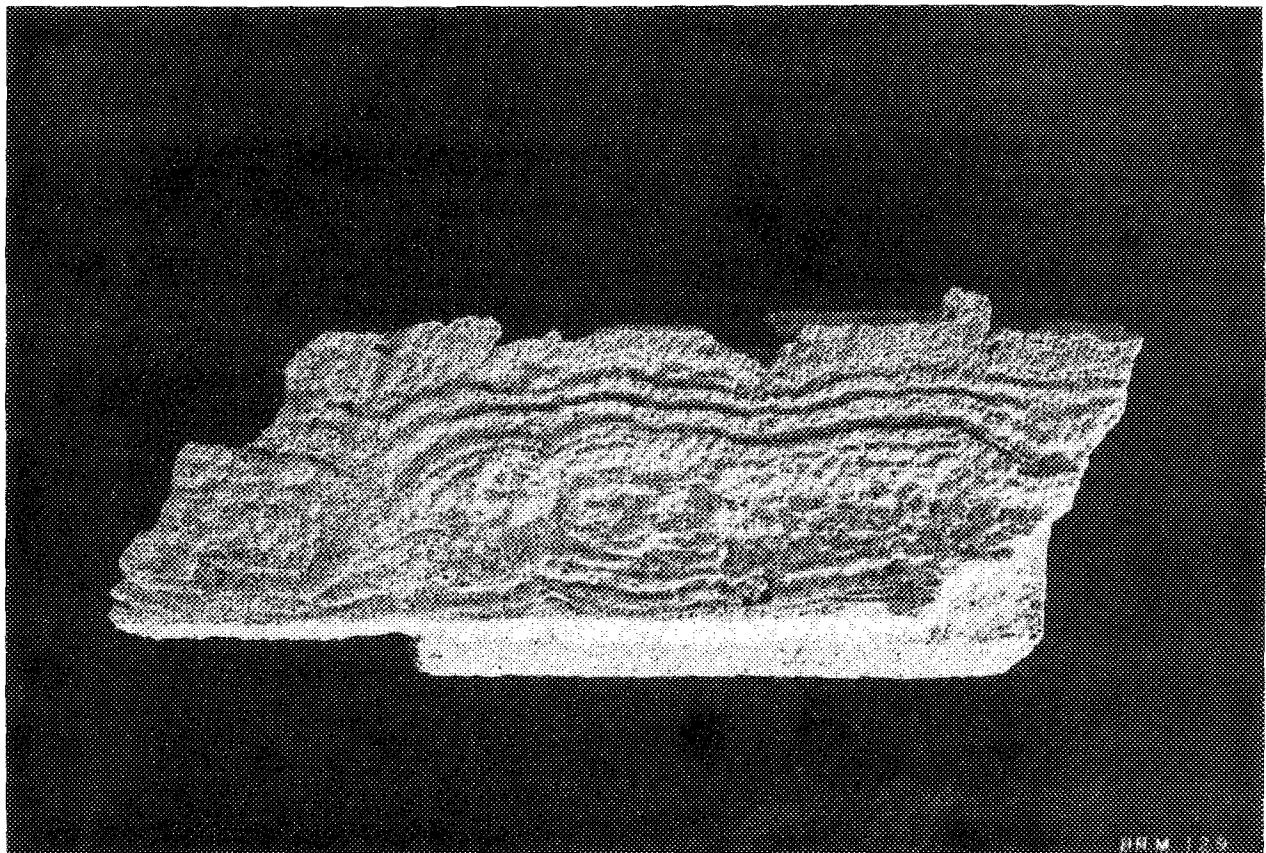
Figure 10 Mortar patterns

Several patterned mortar beds from the regular stretcher courses showed a disturbance in the pattern from the effects of contact with the vertical joints at the ends of the bricks. This disturbance is illustrated in Fig. 10 where the mortar intersects vertical joints at both ends of a brick. Frequently the vertical joints were not completely filled with mortar; therefore, they may have given moisture and the atmosphere easy access to these joints, with the observed results.

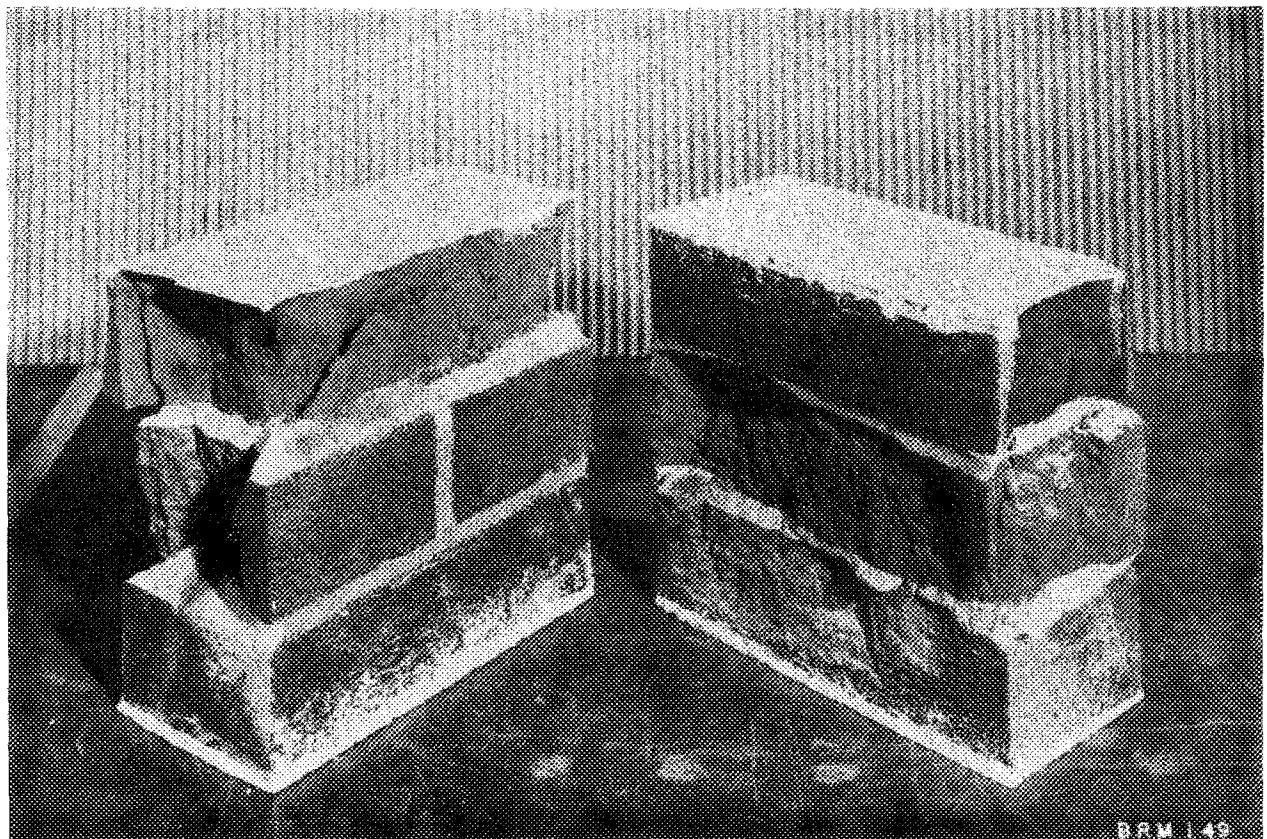
Figure 12 Samples after compressive strength test

The strength of the individual cubes of mortar was very low compared to that of the bricks, but when the compression test was made on combinations of brick and mortar, the failure seemed to occur by cracking or shearing-off of surfaces of one or more of the bricks, damage to the mortar apparently being relatively slight. Two of the samples are shown after test in Fig. 12.
