NATIONAL RESEARCH COUNCIL OF CANADA  
DIVISION OF BUILDING RESEARCH

A STUDY OF THE LIME MORTAR BRICKWORK  
OF A 26-YEAR-OLD HOUSE

Report No. 168  
of the  
Division of Building Research

OTTAWA  
January 1959

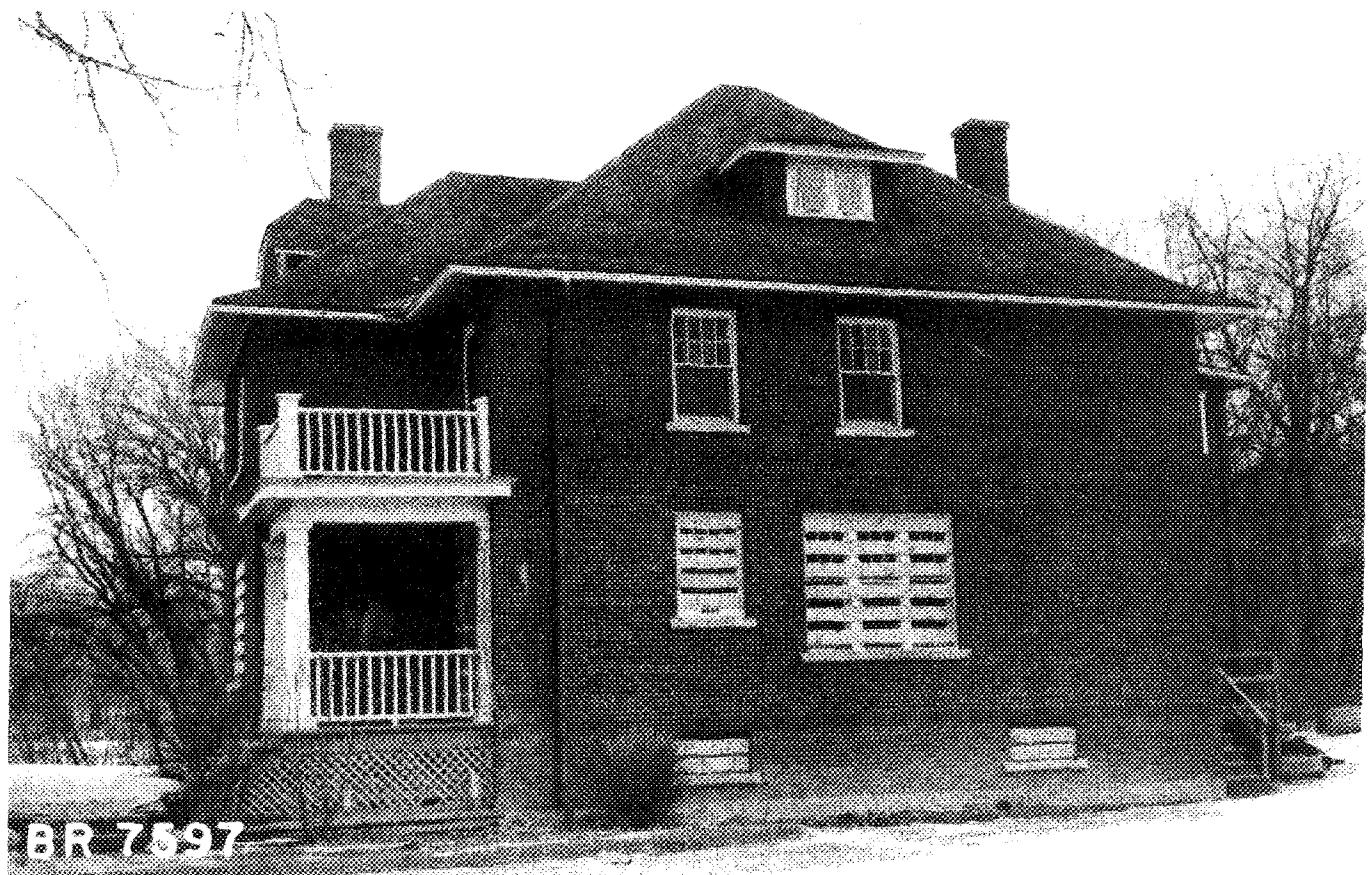
The house shown in Fig. 1, was a large, two-story structure with over-all dimensions about 36 by 30 feet. An overhanging roof which extended between 2 and 3 feet beyond the walls afforded good protection to the walls.

Figure 1 The Merkley house (west wall)

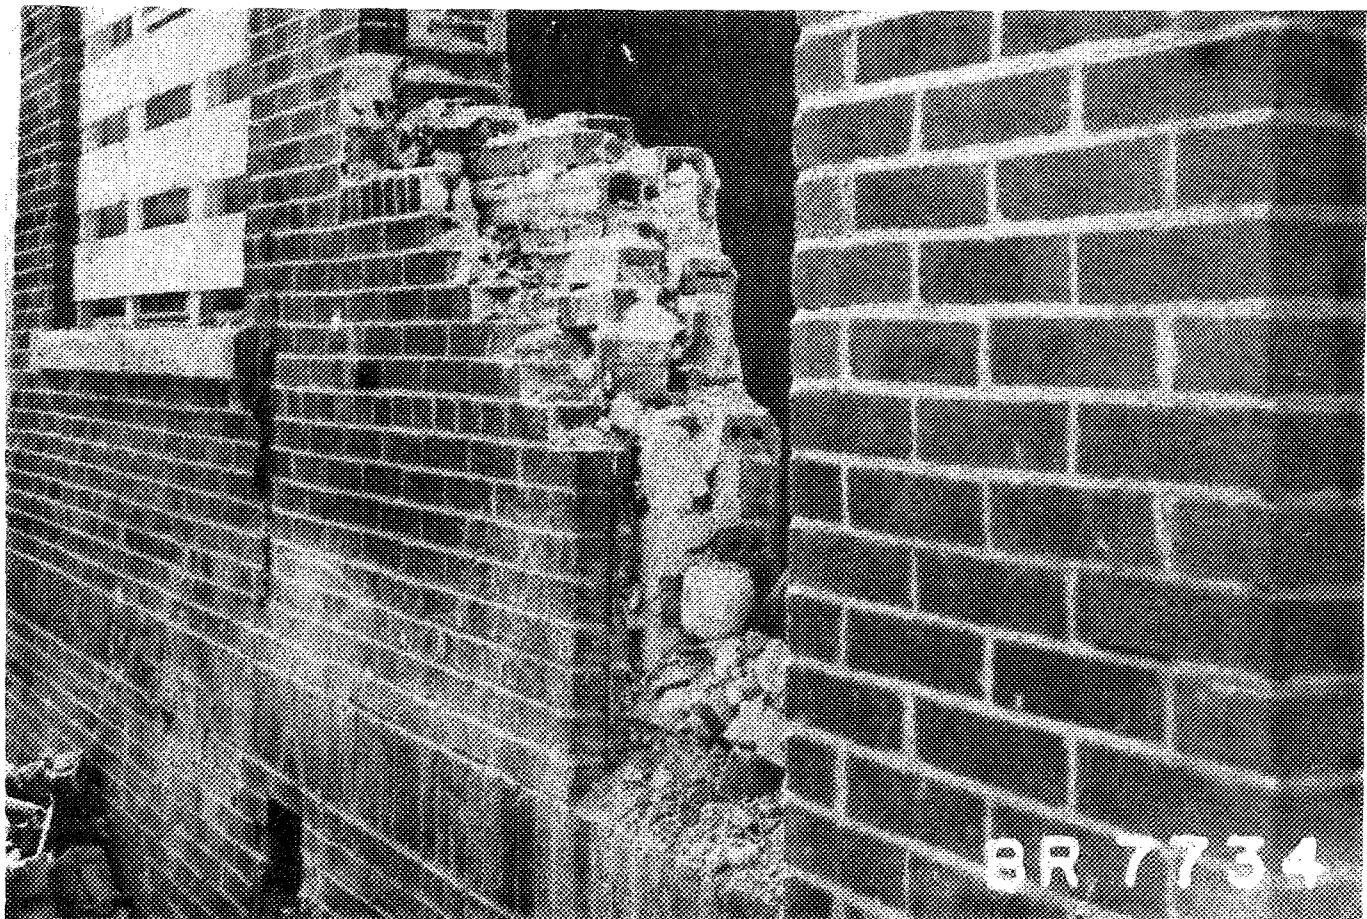
The brick facing above the foundation was bonded to a backing of structural clay tile about 8 inches thick; plaster had been applied directly to the tile to form the inside finish of the wall. The brickwork was laid in a bond pattern consisting of 5 courses of stretchers (bricks laid end-to-end) between the courses of headers (bricks laid end-out to bond to the back-up). During construction the brickwork had been back-plastered and a space which had been left between the bricks and the tiles was filled with sawdust insulation. The structural tiles were T-shaped and interlocked vertically, the stems of the T's pointing inward and outward in the alternate courses. The over-all wall thickness was about 13 inches. The manner of construction of the walls is shown in Fig. 2.

Bricks of types other than those used in the face of the wall had been employed occasionally in the backing, especially around windows and doors where the large tiles could not be fitted. Here, dry-press bricks and some unusual bricks, extruded in a direction parallel to their length, had been used. One variety of the latter had a single, wide, longitudinal core-hole, while another had two circular longitudinal holes (Fig. 2).

Figure 2 Wall construction details

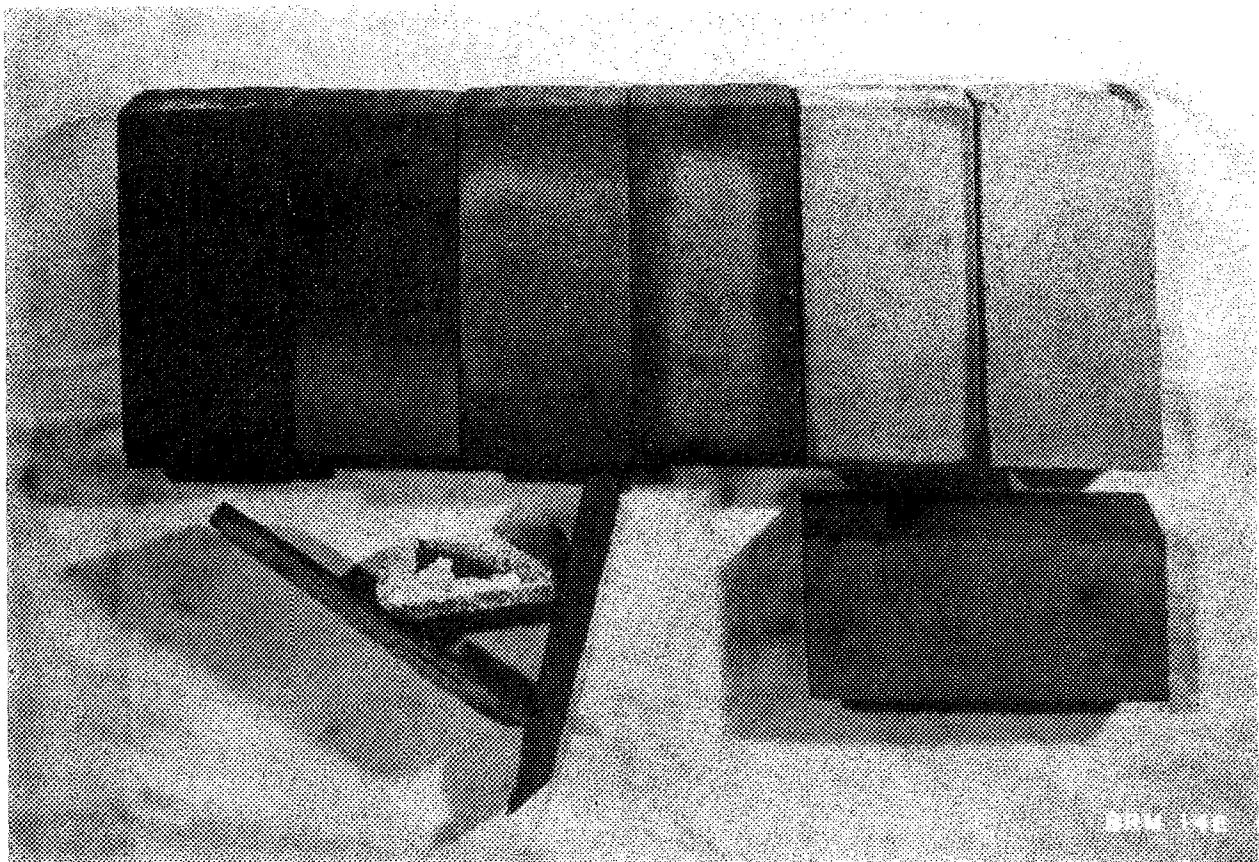
The bricks varied widely in colour but were mainly shades of red and brown; some, however, were almost entirely black. Most were multi-coloured as the result of a "flashing" treatment involving a change of kiln atmosphere during the burning process. Examples of the bricks are shown in Fig. 6; their mortar-covered faces have been removed by means of a diamond saw.

Figure 6 Samples of the bricks

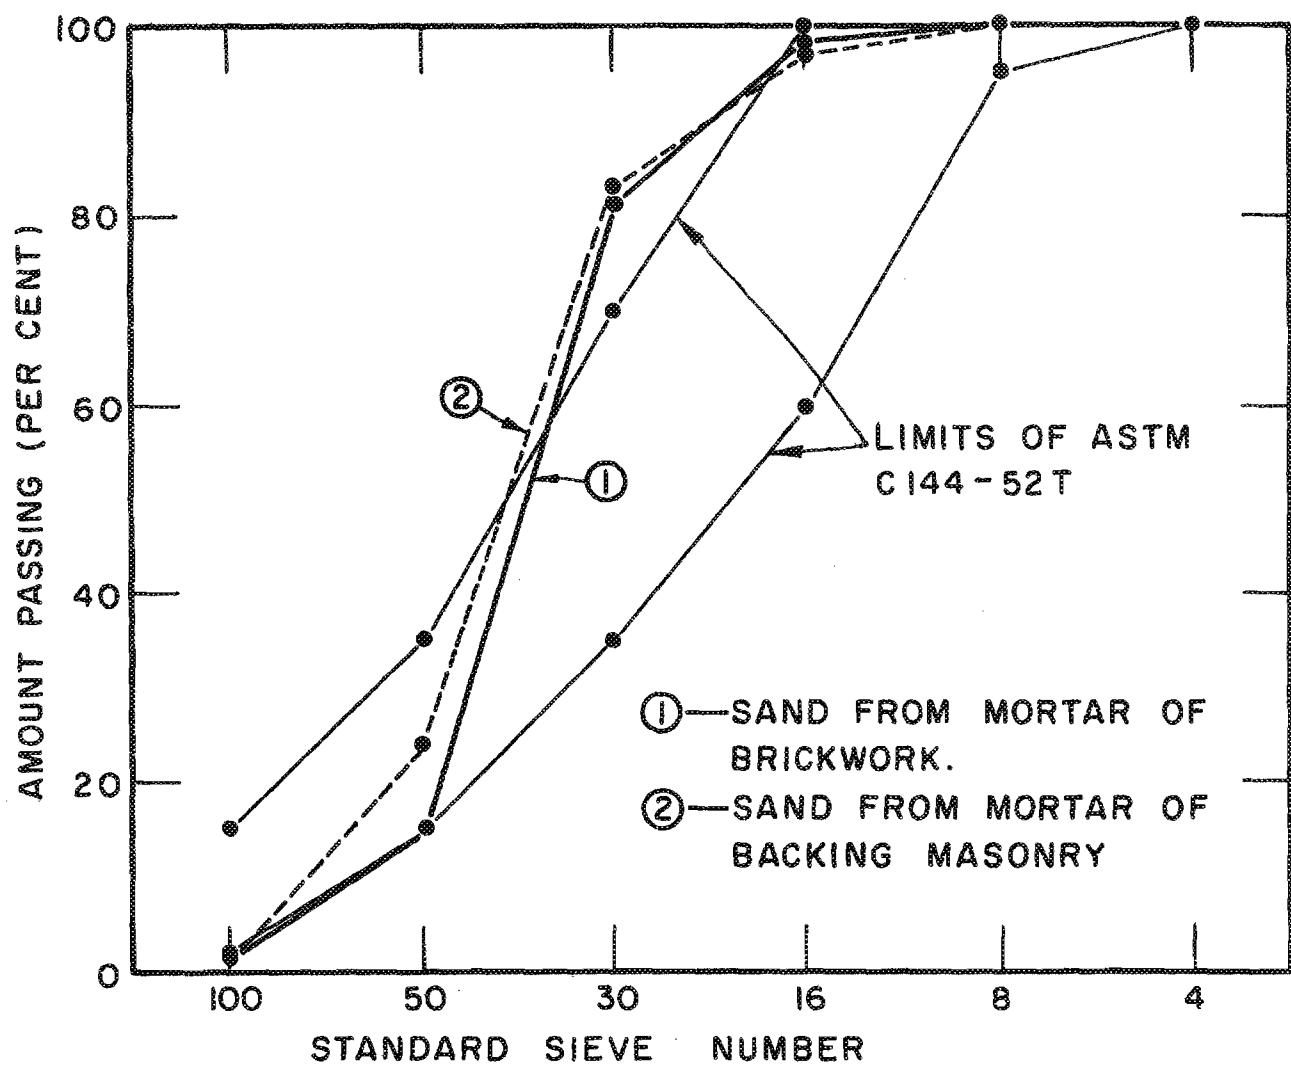
The particle-size grading curves of the sands are shown in Fig. 7 which also indicates, for the purpose of comparison, the limits imposed by A.S.T.M. specification C144-52T on the grading curves for acceptable mortar sands.

**FIGURE 7**  
**PARTICLE-SIZE GRADING CURVES FOR**  
**SANDS FROM MORTAR OF MERKLEY**  
**HOUSE, OTTAWA.**
